**HYUNDAI**
Technical Service Bulletin

GROUP RECALL	NUMBER 18-01-009
DATE February, 2018	MODEL(S) SONATA (NF) AZERA (TG)

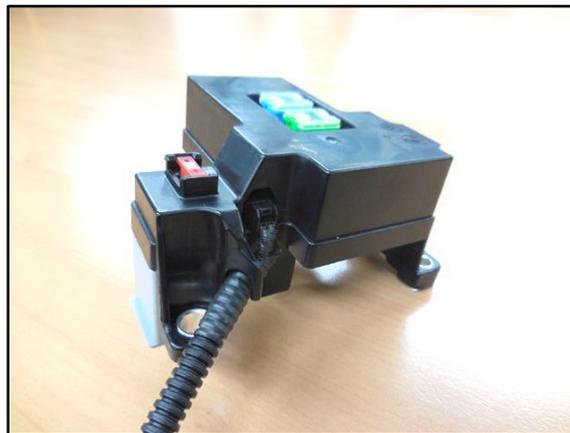
Applicable Vehicles:
